BULLETIN: CA-SB-17-73-23

SERVICE BULLETIN

17DA JOURNAL BEARING LINER

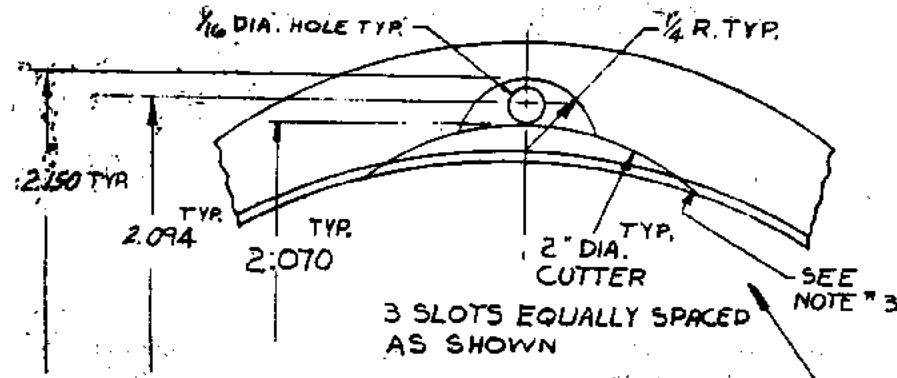
Fig. 1. Old Slot-Style Orifice

In order to improve control of oil flows and pressures in 17DA compressors, a change has been made to the journal bearing liners. The three oil relief slots have been eliminated and three drilled holes (1/16" diameter) have been added to replace them.
