BULLETIN: CA-SB-19-D-73-70
DATE: 11/23/73
PAGE: 1 OF: 3

SERVICE BULLETIN

19DG HERMETIC CENTRIFUGAL INTERNAL AGITATOR ASSEMBLY

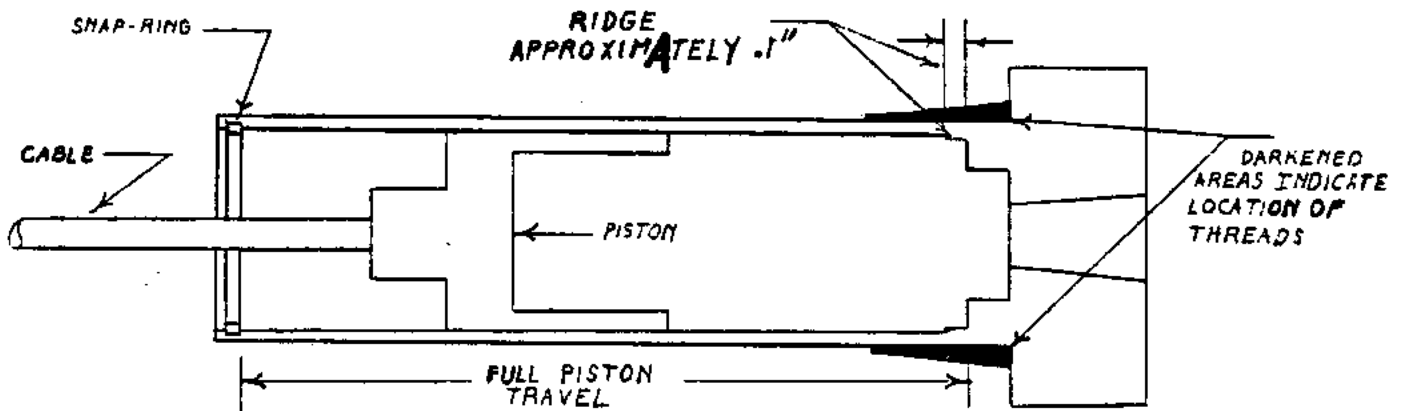
FIG 1

BACKGROUND: Experience has shown that the internal agitator piston may stick in the open position. During high load operation, this condition can go unnoticed. At intermediate loads (when the agitator is normally de-energised) a wide open float valve will cause unnecessary gas by-pass and lower efficiency. It is possible to observe the operation of the float valve and therefore the agitator piston through the sight glasses on the side of the float box. If improper

Remove the agitator assembly. Remove snap ring from end of assembly and remove piston. At the bottom of the housing, there may be a slight step or ridge, (see fig. 1) located approximately 0.10 inch from the bottom of the housing. This ridge exists because the reamer does not bottom completely. Also, tightening the agitator assembly in the float chamber causes the thin-walled housing to contract slightly. As a result, a negative clearance is encountered between the piston and the ridge in the housing, and the piston may remain stuck. Excessive tightening may cause the piston to bind even before it reaches the ridge.

AGITATOR PISTON / CYLINDER ASSEMBLY

Loosening the assembly from the float chamber will sometimes be enough to free the piston and render the unit operational. Using this method requires use of additional thread sealant during reassembly to insure against leakage.

If these methods do not work because a permanent set has been achieved, install a new assembly and check the operation for the sticking condition.

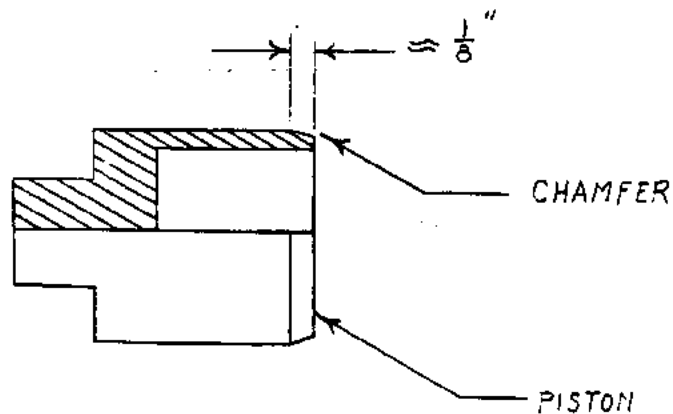
FIG 2

AGITATOR PISTON - CHAMFER LOCATION

Another method available is to cut or file a slight chamfer on the piston. (See fig. 2.) This chamfer should be approximately 1/8 inch wide, and deep enough to clear the ridge.
