BULLETIN: CA-SB-19-E-75-75  
DATE: 9/5/75  
PAGE: 1 OF: 2

## SERVICE BULLETIN

19EA BEARING HOUSING AND THRUST SHOE DESIGN CHANGE

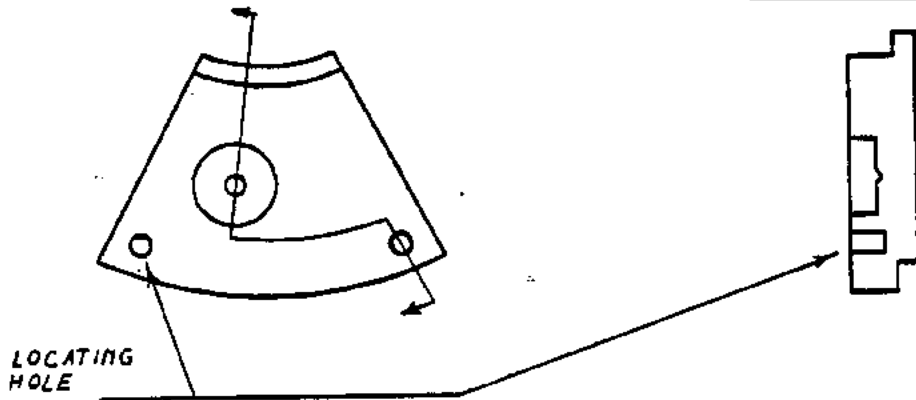
Fig. 1. Old Style 19EA4 Thrust Shoe

Early design high speed bearing housings used 3/32" locating pins to hold the thrust shoes in position. The locating pins were increased to 3/16" in machines shipped after October 1973.

Part No. 19DA33-203 (6 Piece Set)  
Bearing Housing Part No. 19EA42-383

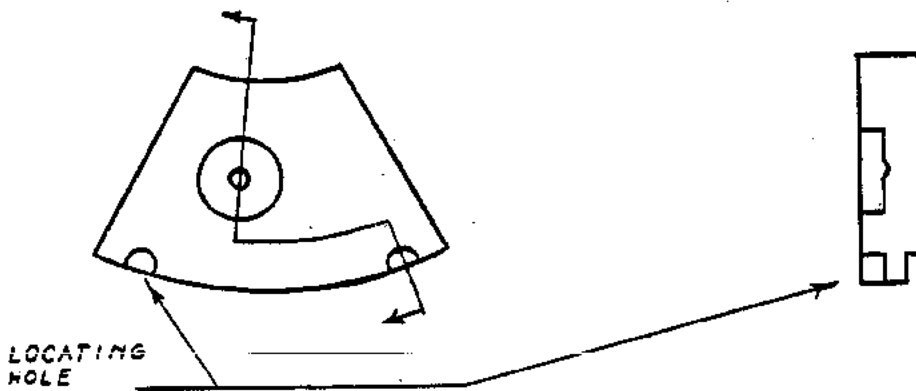
Fig. 2. New Style 19EA4 Thrust Shoe

The thrust shoes used with each of these bearing housings are not interchangeable. Figure 1 shows the early design, locating hole positioning, part number, and the corresponding bearing housing part number. Figure 2 gives the same information for the current design.

Part No. 19EA41-216 (6 Piece Set)  
Bearing Housing Part No. 19EA42-407

Only the new style housing will be available from the Parts Center.
