BULLETIN: CA-SB-17-76-28  
DATE: 1/27/76  
PAGE: 1 OF 2

## SERVICE BULLETIN

SUBJECT: WORM LOCKNUT THREAD

To advise of a change that affects the servicing of a 17MA, PA, SA 30 and 40 compressor.

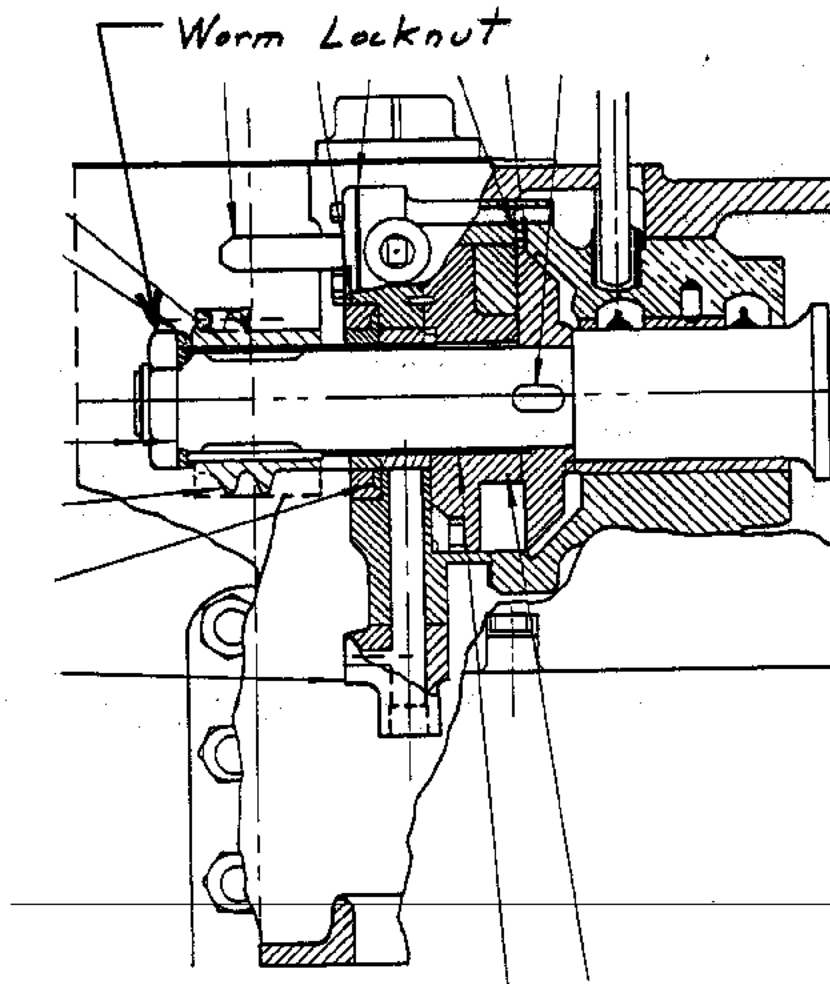
THRUST END BEARING CHAMBER ASSEMBLY

17MA, PA, SA 30 and 40 compressors have a left-hand thread worm locknut. This is the nut (see diagram) that secures the oil pump drive worm and the thrust disk to the impeller shaft.

To remove the worm locknut from 17MA, PA, SA 30 and 40 compressors, turn the nut clockwise as seen from the thrust end of the compressor.
