SERVICE BULLETIN

Title: Guide Vane Crank Arm

Models Affected: 19DK, 19DM, 19EB4, 17/19FA4, 19HR

Number: C9109

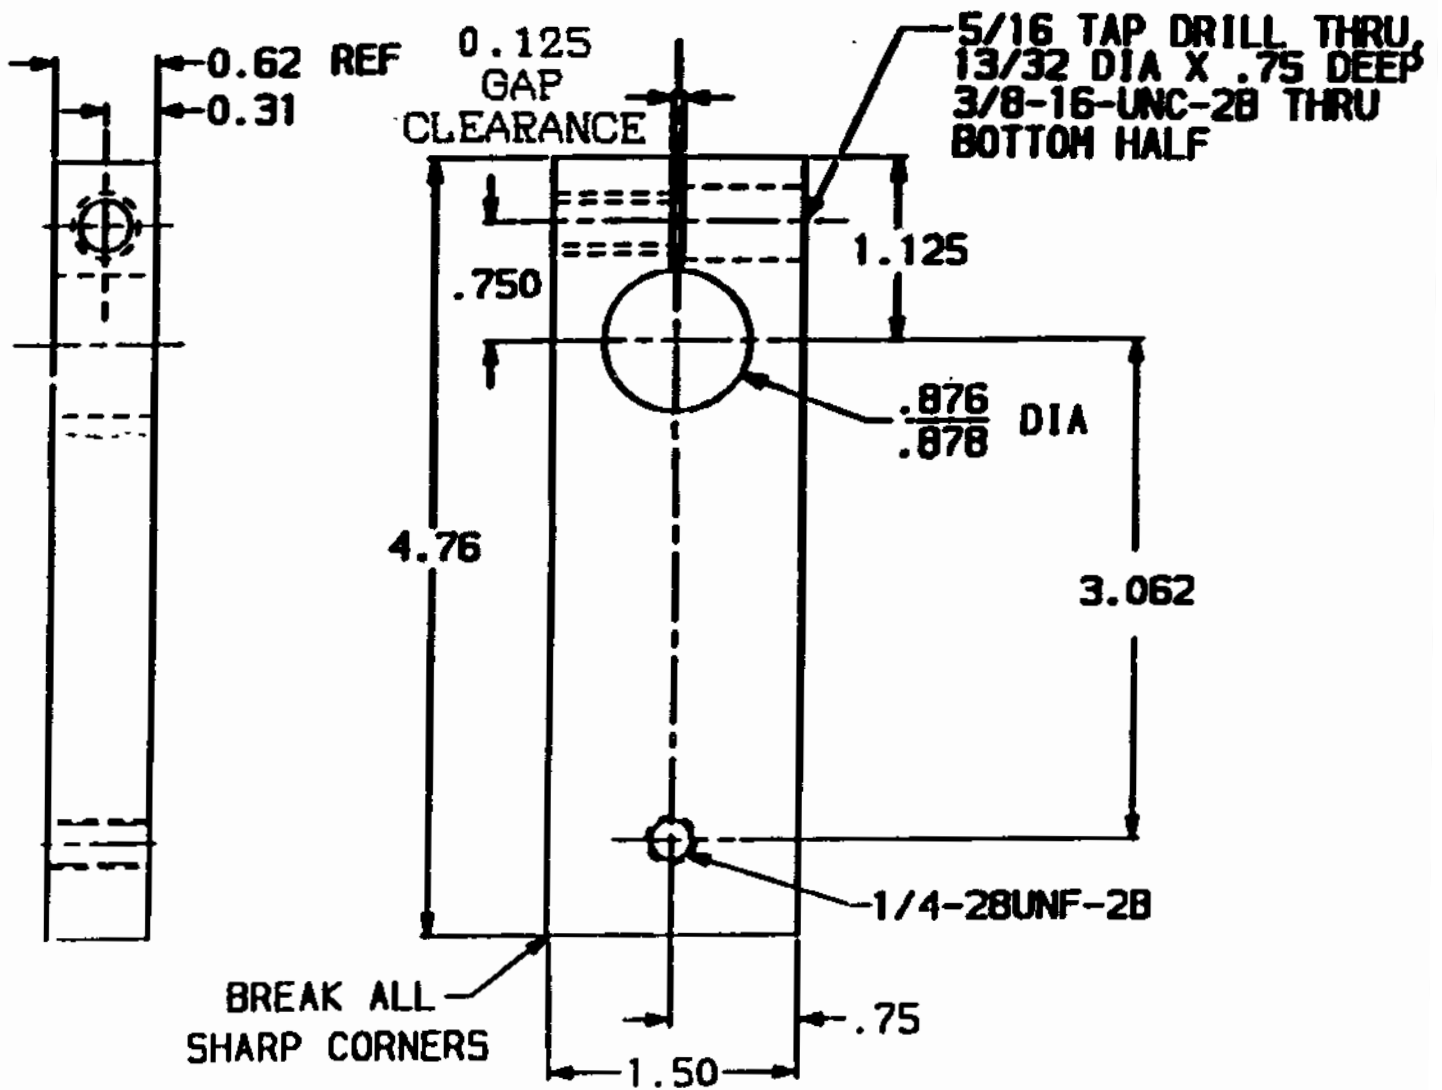
PART NO. 19DM212-1322
GUIDE VANE CRANK ARM

During March 1988, the guide vane crank arm and drive shaft underwent design changes in an effort to eliminate slippage problems. In some instances, however, slippage problems are still being reported. In order to completely eliminate this problem, the new crank arm is going through a slight modification during production. This modification increases the gap clearance from 0.062" to 0.125" allowing the crank to exert more clamping pressure around the drive shaft when the hex screw is tightened. The part no., 19DM212-1322, has not changed.

If a new guide vane crank arm slips, machine the gap clearance to 0.125. This gap clearance is illustrated in the accompanying drawing.
