23XRV Service Updates

October 2012

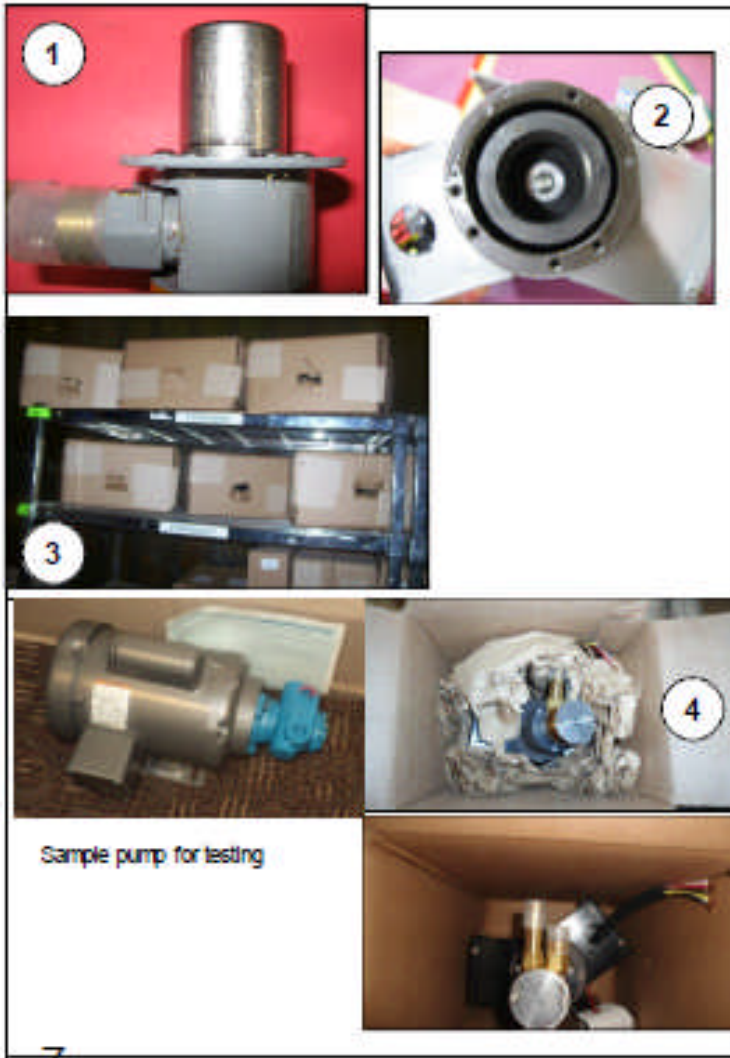
Oil pump motor stall out

Issue/project description: Oil pump motor can stall out or will not start – issue found both on production line and field returns

Milestone	Dates	Status
D1 – ID Team	3/28/12	Complete
D2 – Describe problem	3/28/12	Multiple oil pumps replaced in the field, pumps rejected in QAC lab run test
D3 – Interim CA	3/28/12	All 23XR units tested 100% in QAC lab, alignment tabs now included. Tuthill is developing a standard packaging to prevent transit damage.
D4 – ID Root cause	4/27/12	Shaft is rubbing (rub marks photo 1) → Magnet is shifted off-center in the shaft (photo 2) → Pumps are being damaged in transit (photo 3) → Inconsistent pump packaging by Tuthill (photo 4)
D5 – Choose Corrective action	5/10/12	Alignment tabs to prevent misalignment (complete). Implement standard work in Tuthill packing area with large visuals. Change to different pump – Tuthill or Gerotor to be tested.
D6 – Implement Corrective action	12/31/12	Estimated date for design change, actions at Tuthill complete
D7 Permanent Corrective Actions	12/31/12	Est
D8 – Recognize Team	12/31/12	Est

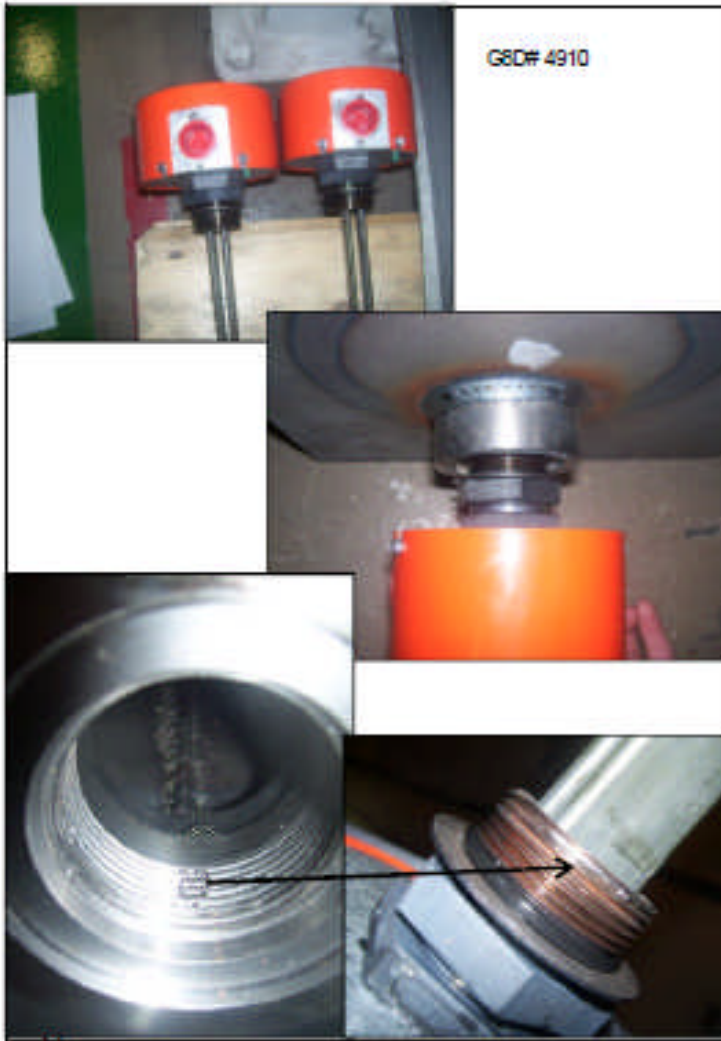
23XRV Oil Heater Leaks

Issue/project description: Leaks found around oil heater in the field and during assembly. Nut on oil heater won't tighten down during assembly

Milestone	Dates	Status
D1 – ID Team	10/25/11	Complete
D2 – Describe problem	10/25/11	Complete
D3 – Interim CA	1/31/12	All heaters at Carrier Charlotte were inspected and suspect pieces were put on hold and returned to Watlow for analysis (1/31). Watlow completed containment of their o-rings (8/1)
D4 – ID Root cause	2/8/12	FB was welded into heater outside the 2° tolerance used for Watlow general spec squareness. Weld spatter damaging threads.
D5 – Choose Corrective action	2/8/12	Watlow implemented fixture to ensure head is mounted straight (complete), noted improvement at CLT assembly. Prevent spatter from entering threads.
D6 – Implement Corrective action	7/31/12	Fixture implemented at Watlow factory.
D7 Permanent Corrective Actions	8/23/12	0 recurrences of issue since fixture implemented
D8 – Recognize Team	8/23/12	Estimated

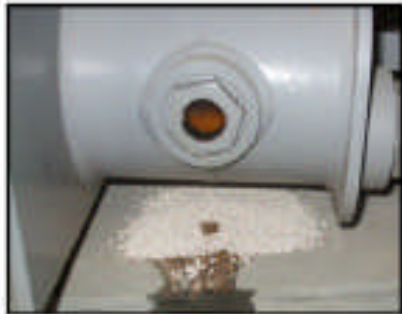
Oil found leaking from sight glass on 23XR oil vaporizer

Issue/project description: 23XR oil vaporizer sight glass leaking on several chillers built for the Arizona school district project.

Milestone	Dates	Status
D1 – ID Team	3/12/2012	Complete
D2 – Describe problem	3/12/2012	Oil found leaking from sight glass of 23XR oil vaporizer
D3 – Interim CA	3/13/2012	Complete
D4 – ID Root cause	3/13/2012	Unable to determine root cause for this particular leak because we did not have the opportunity to examine the units. Similar leaks were found at the Compressor sight glass in the past and issuing a torque wrench resolved the leak.
D5 – Choose Corrective action	3/13/2012	Complete
D6 – Implement Corrective action	3/16/2012	Complete
D7 Permanent Corrective Actions	9/2012 est	Update mfg specifications
D8 – Recognize Team	TBD

A torque wrench has been issued to ensure all sight glasses are secured to manufacturing specification.
