BY JOHNSON CONTROLS

SI0219

Equipment Affected: YCAV & YCIV Chillers

LOW SUCTION PRESSURE AND HIGH FLASH TANK FAULT TROUBLESHOOTING

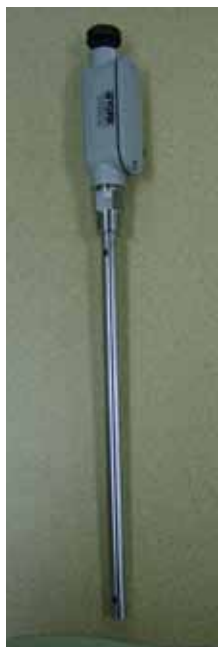
FIGURE 1 - NEW LEVEL SENSOR SUPPLIER INTRODUCED INTO PRODUCTION 10/09

A new level sensor supplier has been qualified. The first of the new sensors (*see Fig.1*) will begin showing up on new chiller start-ups and as spare parts at the beginning of 2010. These sensors also have the capability of simply changing the probe head versus removing the entire sensor when a problem occurs, eliminating the need to remove refrigerant from the low side of the system. They can also be field calibrated to compensate for a supplier calibration error.

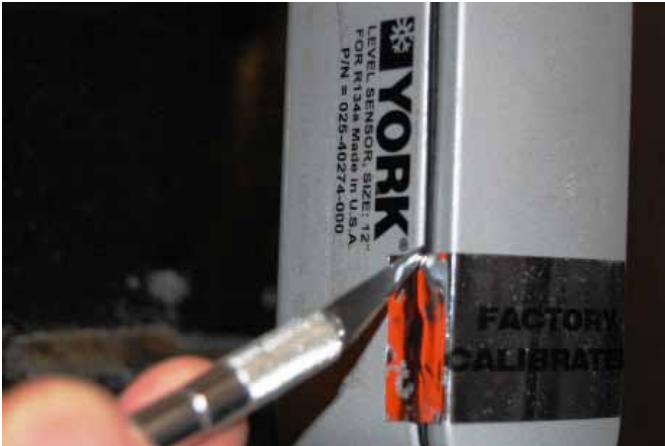
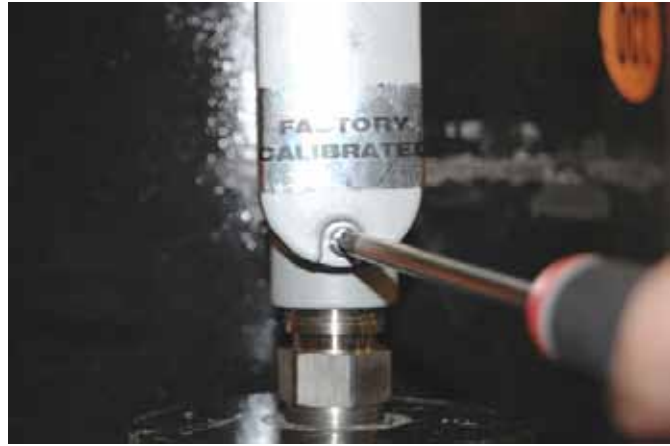
If a significant error in the level sensor display is causing nuisance low suction pressure trips or high flash tank levels, the level sensor can normally be field re-calibrated. The following procedure outlines the steps required to make the adjustment:

1. Use a utility knife and slit the “Factory Calibrated” label along the joint of the sensor cover and head. Unscrew the two cover screws using a #2 Philips screwdriver. Remove the sensor cover.
