Fan Bearing Maintenance & Troubleshooting

TWIN CITY FAN & BLOWER | WWW.TCF.COM

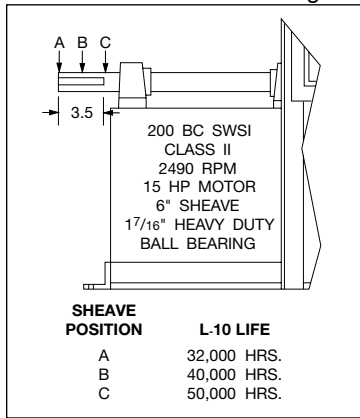
Figure 1 shows a typical fan selected to use a sheave with a six inch diameter on the fan shaft. With the sheave mounted at the end of the shaft, as far away from the bearing as possible, the L-10 life calculates to be 32,000 hours. (See ED-1200 for an explanation of L-10 life.) By moving the sheave 1.25" closer to the bearing, the life is increased to 40,000 hours. When the sheave is moved in another 1.25" so that it is as close to the bearing as possible, the life increases to 50,000 hours. The lesson learned by this example is to maximize bearing life by mounting the sheave as close to the bearing as possible.

Figure 1. Effect of Sheave Location on Bearing Life

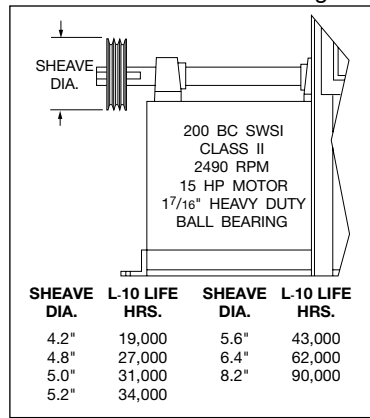
Most belt drives are selected using computer programs. The user puts in the information and the computer selects several sheave and belt combinations that will work, and usually highlights the least expensive. But the combination selected has a significant effect on bearing life. Large sheaves result in less belt pull and longer bearing life. Figure 2 shows the L-10 life for different fan sheave diameters. All of them are viable drive selections. The L-10 life varies from 19,000 hours with a 4.2 inch diameter sheave, to 90,000 hours with an 8.2 inch diameter sheave. Avoid the selections with the smallest sheave sizes. They are probably not the least expensive anyway since they require more belts. The best drive selection is one with a reasonable sheave size and moderate cost.

Figure 2. Effect of Sheave Diameter on Bearing Life

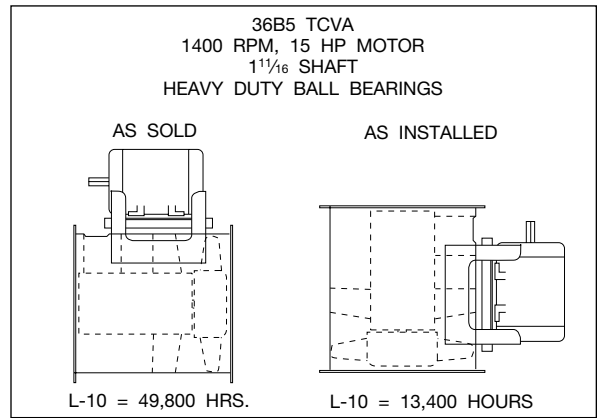
Fan orientation affects bearing life. A fan designed to operate with its shaft positioned horizontally will have a lower bearing life when positioned with a vertical shaft. This is due to the additional thrust loads put on the bearings from the shaft and impeller weight. Figure 3 shows an example. An axial fan designed for horizontal duty has an L-10 life of 49,800 hours. Tipping the fan so that the shaft is vertical lowers the bearing life to an unacceptable level of 13,400 hours. If a fan is to operate with a vertical shaft, make sure to order it for this orientation.

Figure 3. Effect of Shaft Position on Bearing Life

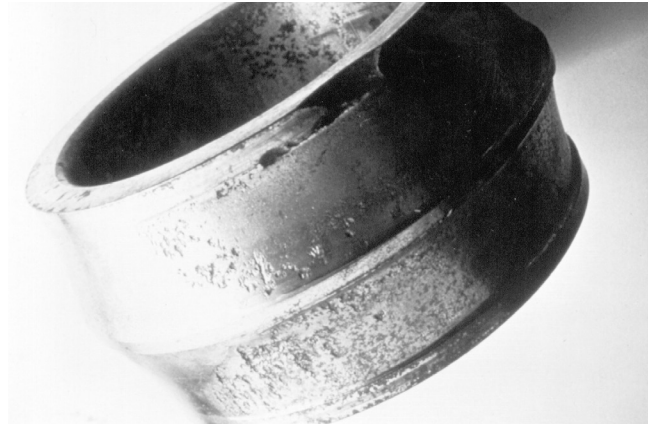
Figure 5 shows an inner race that has had a normal fatigue failure. The repeated loading and unloading of the race every time a roller passes eventually causes microscopic fatigue cracks to form under the surface.

In time, these cracks grow to the point where small portions of the surface flake off. This process is called "spalling" and the flaws left in the surface are called "spalls."

Figure 5. Normal Fatigue Failure

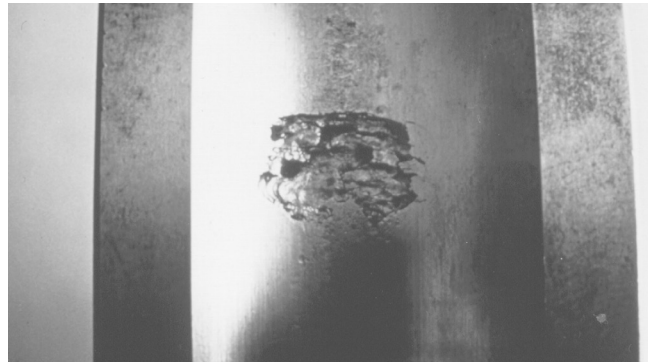
With continued operation, the spalls grow until the bearing becomes noticeably noisy. Figure 6 shows an inner race that has a severe spall. In addition to being noisy, it is also likely that this bearing would show high levels of vibration. The time required for the spalling to cause catastrophic bearing failure will vary with the load on the bearing and its speed. Usually the bearing will run for a while after it becomes noisy, but once noise is heard, prepare to have the bearing changed before it fails suddenly.

Figure 6. Spall

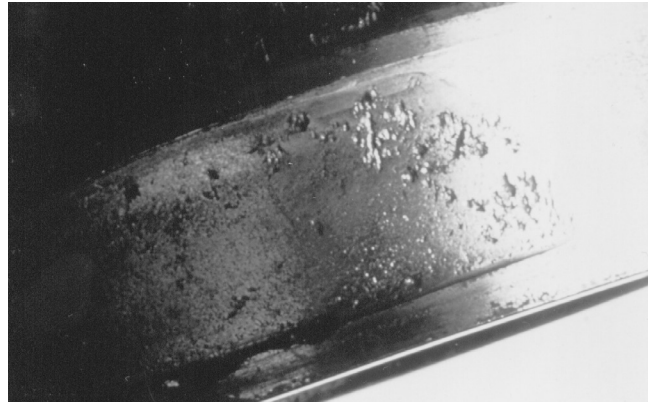
Inadequate lubrication can lead to spalling as seen in Figure 7. This bearing also shows signs of excessive

Figure 7. Spalls & Wear Patterns in the Race

wear due to inadequate lubrication. The rollers have worn a very deep wear pattern in the race.

Material that flakes out of spalls and other contaminants from other sources such as dirty grease or worn seals dents the races when caught between the rollers and races. Figure 13 shows an inner race with severe particle denting. Figure 7 also shows signs of particle denting. Each dent is a stress concentrator, which increases the stress in the area around the dent and accelerates the fatigue failure process.

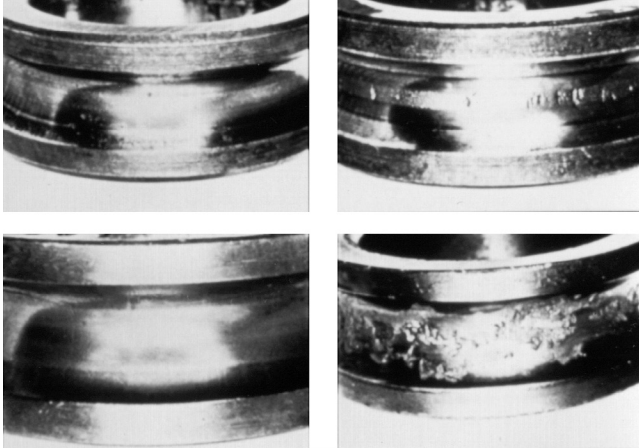
Figure 8 shows the progressive failure of a bearing due to inadequate lubrication. At first there are traces of waviness, or a slight roughening of the race. With time small cracks develop, which lead to a modest amount of spalls and eventually the severe amount of spalling shown on the lower right.

Figure 8. Progressive Failure of a Bearing Due to Inadequate Lubrication

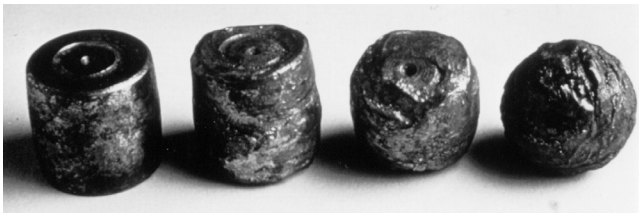
If the bearings continue to operate with inadequate lubrication, the evidence that shows this to be the mode of failure becomes destroyed. Notice how the spherical bearing rollers shown in Figure 9 become damaged with continued operation.

Figure 9. Damaged Spherical Bearing Rollers

If the bearing had been taken out of operation when the roller was in the condition shown on the left, it would be possible to determine the cause of failure. By the time the bearing completely failed, it had run so hot that the steel softened and the bearing became deformed. At this point it is impossible to tell what caused the initial failure. If you are having unexplained bearing failures, it is best to take the bearing out of service when you first notice noisy, hot, or vibrating operation. The evidence showing the initial cause of failure is probably still visible, and it will give you an idea as to what action to take to prevent additional failures.

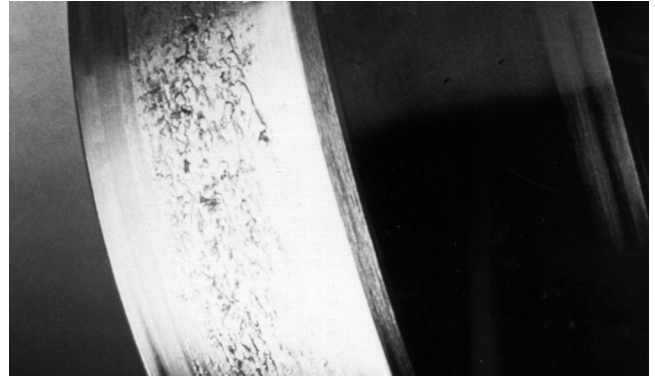
Under the right conditions the heat generated by metal-to-metal contact causes the two surfaces to adhere for an instant. Small portions tear out from one surface and adhere to the other surface. This is "smearing" and is shown in Figure 10.

Figure 10. Smearing

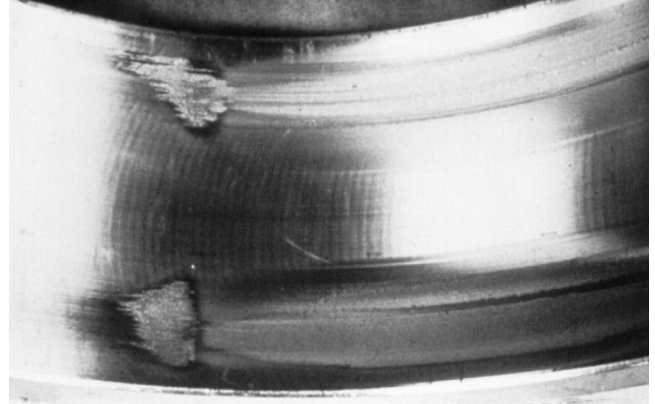
"Skid smearing," shown in Figure 11, occurs on lightly loaded bearings. As the rollers come around and enter the lower half of the bearing, they go from being

Figure 11. Skid Smearing

unloaded to being under load. With the light load it takes them some distance to roll properly, and they skid against the race causing smearing.

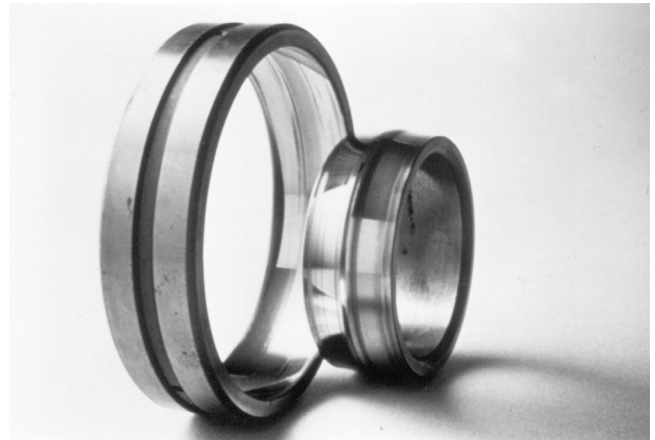
Figure 12. Highly Polished Surfaces Due to Inadequate Lubrication

Inadequate lubrication can sometimes cause the bearing surfaces to become highly polished as Figure 12 shows. Even though the surface looks nice, this is an indication of trouble. With continued operation the surface will change to a frosty appearance and eventually spall.

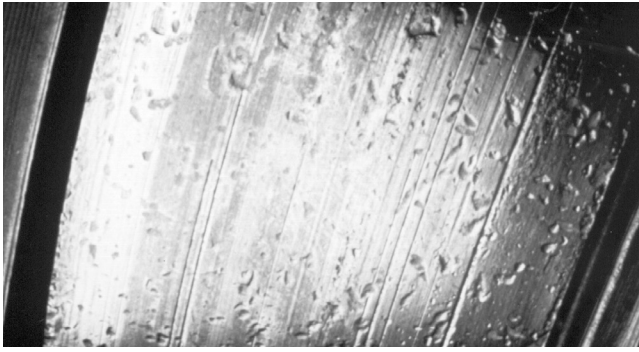
Figure 13. Severe Particle Denting

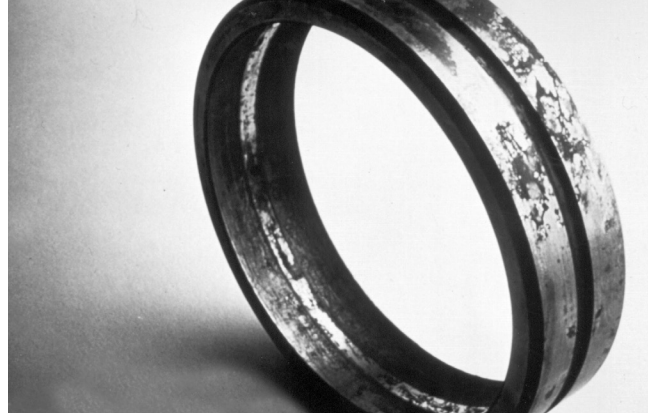
Keeping moisture out of bearings is necessary to achieve long life. Figure 14 shows a bearing severely damaged from water corrosion. This much damage was

probably due to seal failure, possibly in a “wash down” environment. High moisture applications require the use of grease that has rust inhibiting properties. Frequent relubrication is necessary, to insure that all bearing surfaces are coated with a protective layer of grease and that the rust inhibitors are replenished. Figure 15 shows a spherical roller bearing roller that has rusty ends from moisture in the lubricant.

Figure 14. Water Corrosion

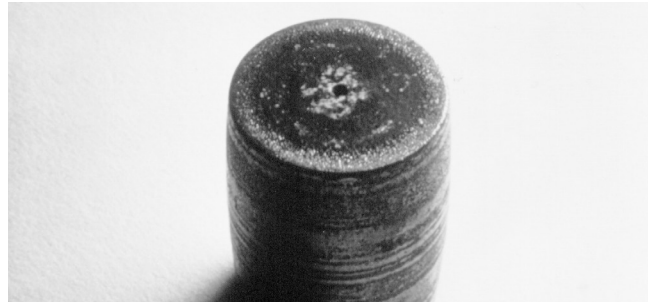
Figure 15. Bearing Roller with Rusty Ends Due to Moisture in the Lubricant

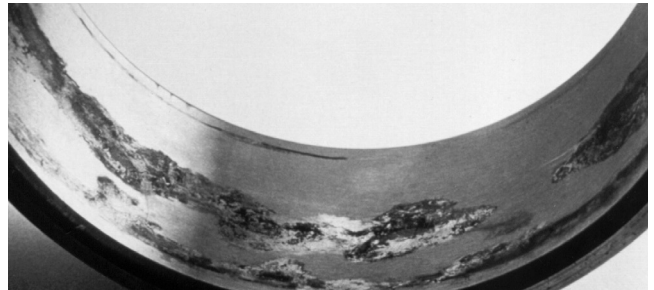
Water from condensation causes corrosion in idle fans. This is particularly true for fans in high moisture areas, located outdoors, or improperly stored outdoors. Figure 16 shows an outer race damaged by puddle corrosion. Moisture or dew condensing in the bearing settles to the bottom of the race in puddles and causes rusting. Twin City Fan Companies packs ball and unit roller bearings completely full of grease prior to shipment. Split pillow block spherical roller bearings are shipped with the bearing insert packed full. This minimizes the chances of having puddle corrosion occur during shipment and storage. This practice covers all components with grease, and insures there are no pockets of air where water can condense. At startup the excess grease purges out of the bearing, which gets a little messy but is better than having a damaged bearing.

Figure 16. Puddle Corrosion

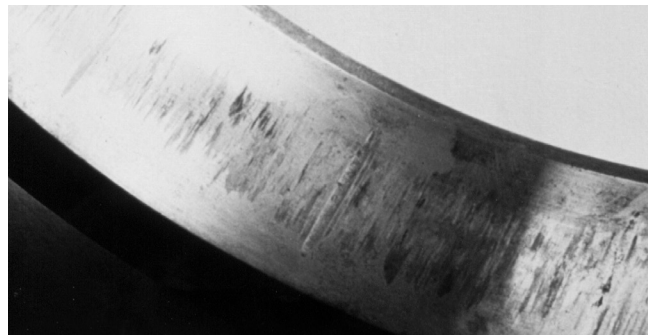
Figure 17 shows damage to an outer race from a bearing subjected to vibration while the unit is not rotating. Notice the even spacing of the marks, which correspond to the roller spacing. You can also see marks where the rollers came to rest in different locations. This type of damage, called “false brinnelling,” occurs when small portions of the race get rubbed away. The remaining area is ideal for starting fatigue, and the abrasive material rubbed off contaminates the grease which accelerates bearing wear.

Figure 17. False Brinnelling

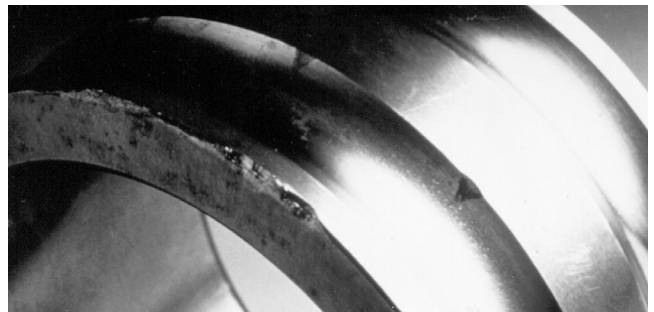
“True brinnelling” occurs when a bearing is subjected to impact and the rollers dent the races. Figures 18 and 19 show damage caused by improper mounting. Impact from hammering on the outer race or the bearing housing causes true brinnelling of the races. If it is necessary to tap on a bearing to get it into position, tap on the inner race so that the rolling elements do not carry the load. Dropping a bearing prior to mounting can also cause true brinnelling. Like false brinnelling, the marks are evenly spaced and the damage will eventually develop into spalls. Figure 20 shows spalls resulting from true brinnelling.

Figure 18. True Brinnelling

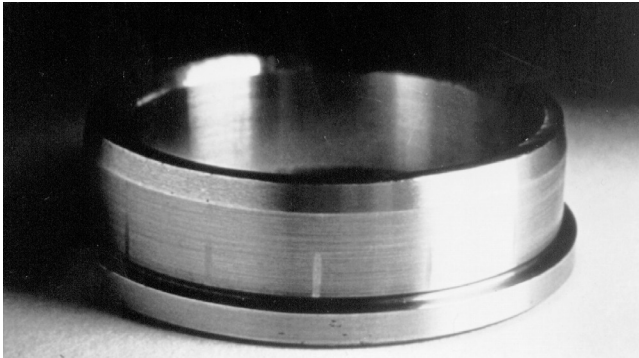
Figure 19. True Brinneling

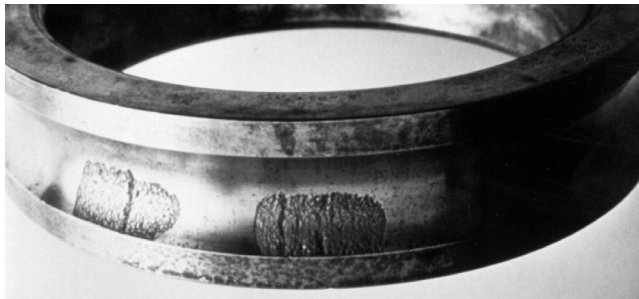
Figure 20. Spalls Resulting from True Brinneling

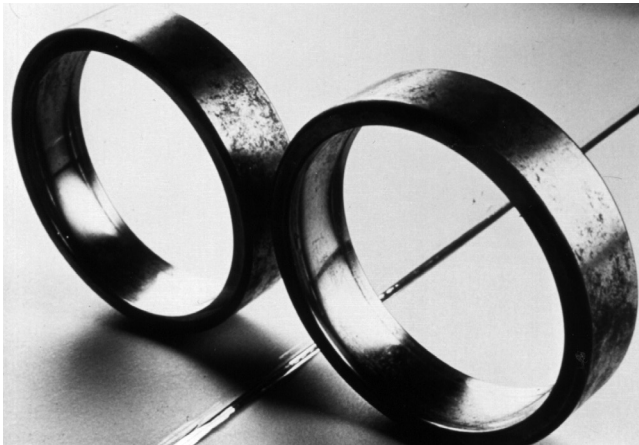
Mounting a bearing pillow block on a warped or crowned surface, or improperly shimming a pillow block can pinch the outer race. As seen in Figure 21, this causes two load zones on the outer race 180° apart.

As the rolling elements pass through the pinched area, the load between them and the races increases. If the severity of the pinch is high, a drastic reduction in the life of the bearing will result.

Figure 21. Two Load Zones on the Outer Race

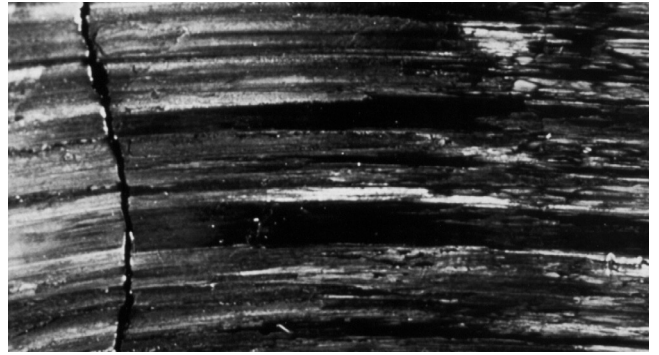
failures. Figure 22 shows the surface of a bearing bore that had too much clearance. The shaft turned in the bore, smearing the surface.

Insufficient tightening of the setscrews on a set-screw mounted bearing causes this type of failure. It can also be caused on a tapered adapter mounted bearing by not tightening the adapter lock nut enough. The damage to the surface resulted in a crack.

Figure 22. Smearing on a Bearing Race

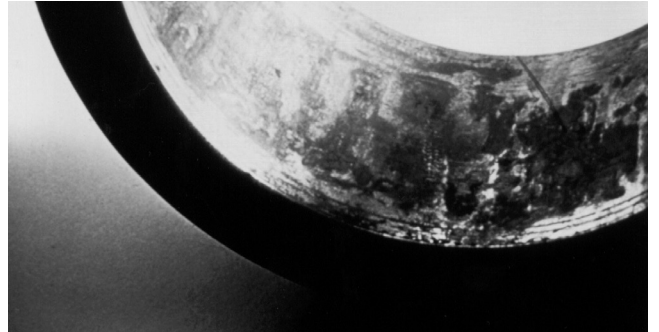
The bore of the bearing shown in Figure 23 shows signs of serious fretting corrosion. Microscopic movement between the shaft and the bore causes the rust colored patches to develop. Small amounts of fretting are common with setscrew mounted bearings and are not detrimental to bearing life. Advanced cases, caused by loose mounting, can lead to cracks.

Figure 23. Fretting Corrosion on Bearing Bore

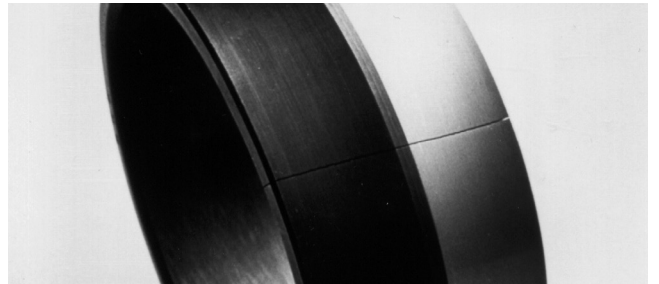
Tightening the locknut of an adapter mounted bearing too much can crack the inner race as shown in Figure 24, or the outer race as shown in Figure 25.

This also occurs by exposing the bearing on a high temperature fan to excessive temperatures. This easily happens when shutting down high temperature fans when they are hot, or by exposing them to high temperatures while idle.

Figure 24. Cracked Inner Race

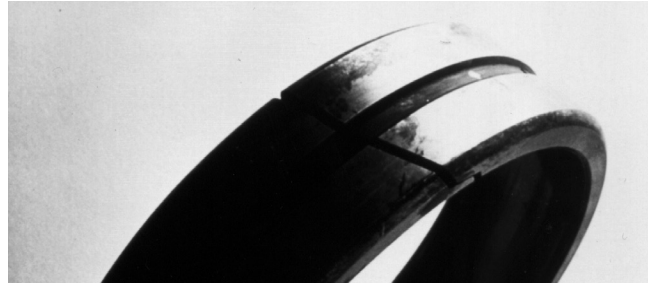
Figure 25. Cracked Outer Race

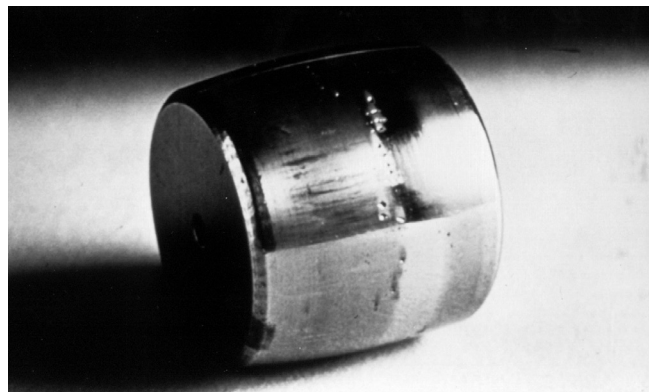
Figure 26. Pits Caused by Electrical Current

Allowing electrical current to pass through a bearing can cause damage. Figure 26 shows a spherical roller with pits in its surface caused by electrical current. This type of damage commonly occurs when welding balance weights on a fan wheel with improper grounding. To avoid having the welding electrical current pass through the bearings, attach the grounding clamp to the wheel or shaft when adding balance weights.
