PRODUCT UPDATE ACTION NOTICE

PU 07-06

Subject: Field Rework Instructions for Failed Danfoss® ETS 250 Valves on YCAV/YCIV Chillers

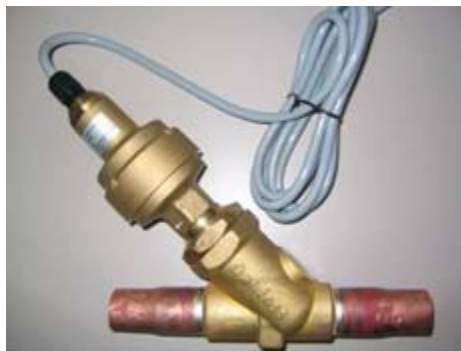
Figure 1: Example Valve

Problem: YCAV/YCIV chillers refrigerant control valve (Drain and Feed valve - Figure 1) piston unscrews from the drive motor, typically causing low suction pressure faults. Affected systems normally run only for a short period of time before shutting down on a fault. Low flash tank refrigerant levels are also common when the Feed valve fails due to the loose piston.

Affects: This problem affects all Danfoss ETS 250 Drain and Feed valves (Figure 1) used on all YCIV and most YCAV chillers manufactured between August 2006 and March 2007. See Table 1 for the specific valve model numbers.

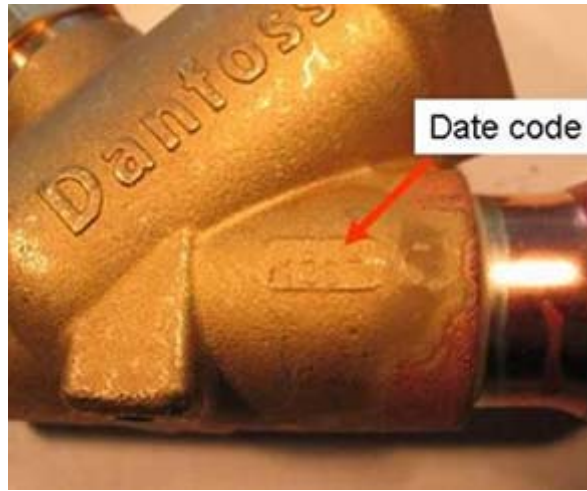
Figure 2: Date Code

- Verify the date code on the stepper motor assembly. The date code is a four-digit code stamped on the side of the valve body. The first two digits are the week of the year and the last two digits are the year. Valves made after the twelfth week of 2007 (stamped with date code 1207 or later) do not need to be reworked because the factory reworked them prior to shipment. See Figure 2.

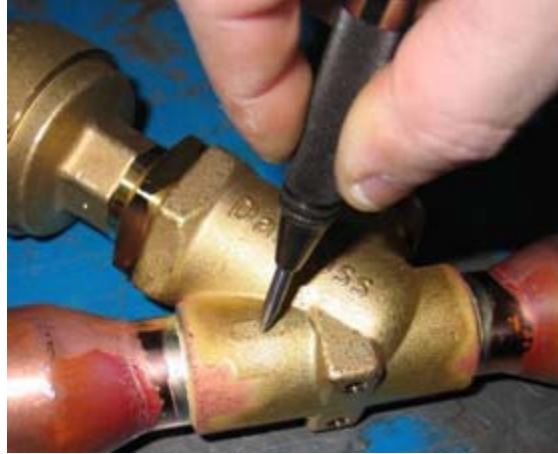
Figure 3: Reworked Valve with a Punch Mark

- Check if the valve has a punch mark on the side of the valve body opposite the date stamp. This punch mark indicates that the valve was reworked by the factory. If the valve has been reworked, you do not need to take further action. See Figure 3.

8. Carefully make one center punch mark on the side of the valve opposite the date stamp to identify that the valve is reworked. Verify the punch is easily visible for future reference (Figure 3).
9. Reconnect the stepper motor cable plug.
10. Go to *Detecting Leaks and Returning the System to Operation*.

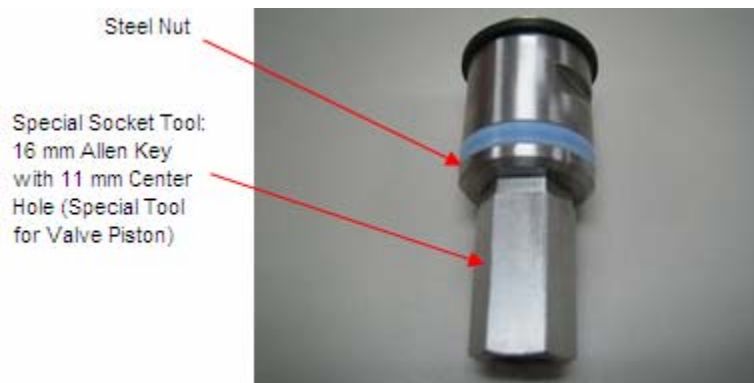
Figure 4: Danfoss 16 mm Allen Key Inserted into a Steel Nut

- 41 mm hex socket and torque spanner set to **165 N·m (122 lb·ft)** (valve top removal)
- 27 mm open-end spanner and torque spanner set to **50 N·m (37 lb·ft)** (stepper motor removal)
- 8 mm Allen key and torque spanner set to **25 N·m (18.5 lb·ft)** (valve piston removal)
- 16 mm Allen key with an 11 mm center hole (valve piston tightening). See Figure 4.

Note: This tool is supplied by Danfoss and has been sent to your Service Branch Manager in a special mailing for you to use.

1. Place the special 16 mm Allen key tool with an 11 mm center hole on the steel nut of the piston (Figure 4).
2. Using the 8 mm Allen key torque spanner in the brass end of the piston and the special tool inserted into the piston, tighten to **25 N·m (18.5 lb·ft)**. This is accomplished easily on a tabletop vice or on the floor using a crescent wrench (Figure 9).

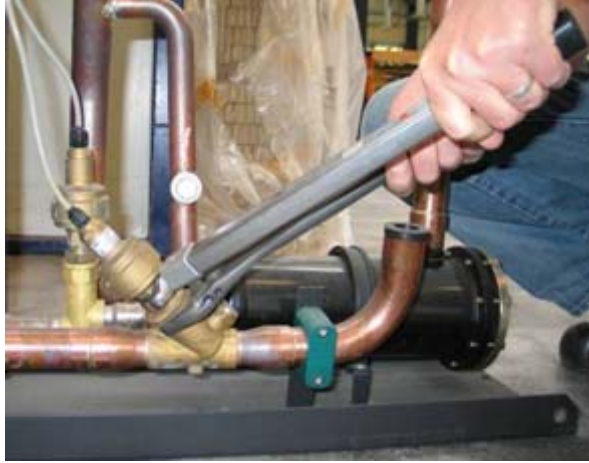
Figure 5: Stepper Motor

1. Locate and remove the stepper motor plug (black water-tight plug connecting the chiller wiring harness to the control panel). **Do not** attempt to remove the wire cable from the top of the valve stepper motor.
2. Remove the stepper motor using the open-end spanner (27 mm) or wrench. During removal, be sure to backwrench the valve body (hold the valve body steady with another wrench [41 mm]) to prevent damage to the installed valve. See Figure 5.

6. Set the piston to its fully closed position, and screw the motor into the piston spindle.
7. Tighten the stepper motor to a torque of **50 N·m (37 lb·ft)**. Be sure to backwrench the valve body with another wrench to prevent damage to the valve body (Figure 5). **Do not overtighten or you may strip the threads and damage the valve.**

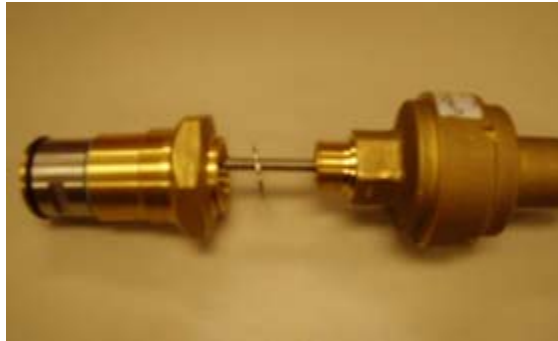
Figure 6: Old Gasket in Assembly

3. Discard the metal gasket on the valve top or stepper motor (Figure 6).

3. Tighten the valve top to a torque of **165 N·m (122 lb·ft)** (Figure 7). **Do not overtighten or you may strip the threads and damage the valve.**
4. Check again that the piston can move smoothly from the closed position to the open position. Use the stepper motor screw inserted into the piston, if needed.
5. Install one new metal gasket on the stepper motor (Figure 11). Remember to remove the old gasket (Figure 6).

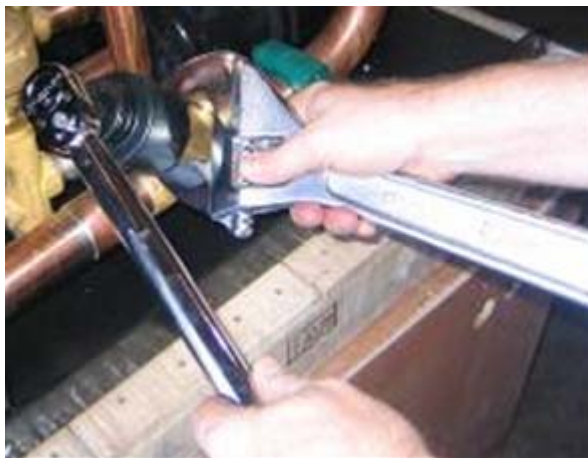
Figure 7: Valve and 41 mm Hex Socket

4. Remove the valve top using the 41 mm hex socket wrench. Be sure to backwrench the valve body with another wrench to prevent damage to the installed valve. See Figure 7.

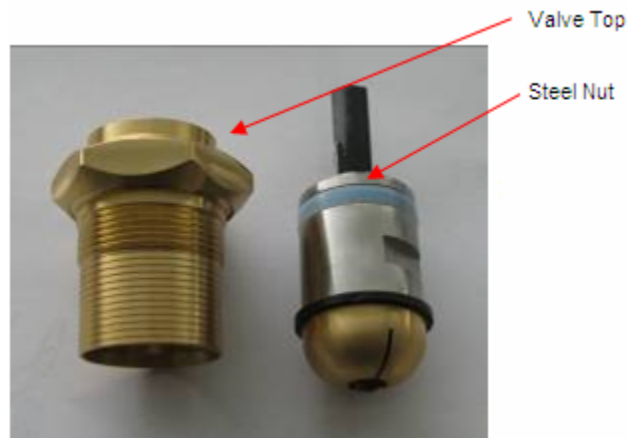
Figure 8: Valve Top and Piston (with Steel Nut)

5. Separate the piston from valve top (Figure 8).

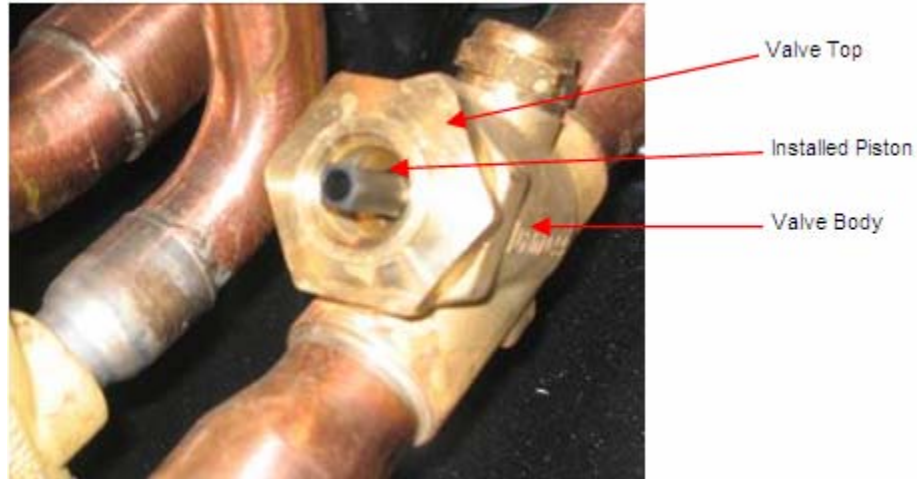
Figure 10: Assembled Piston and Valve Top/Body

1. Place the piston in the valve top. Be sure the piston can move smoothly to the top and bottom of the valve.
2. Assemble the piston and valve top on the valve body (Figure 10).
