23XRV Service Updates

October 2012

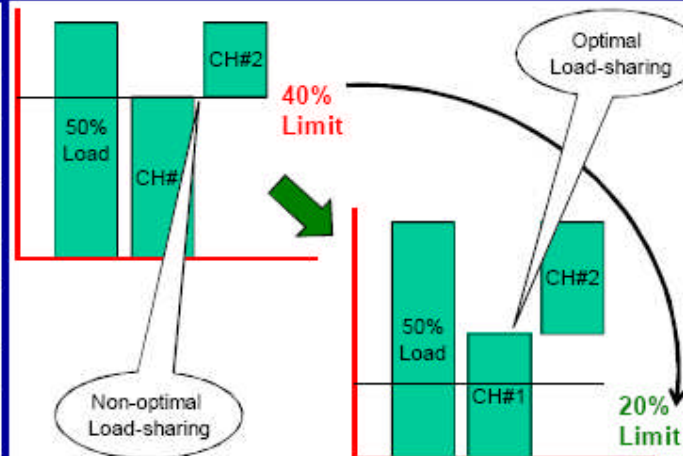
IRP Issue Description : 23XRV Lead-lag function does not operate properly. Running one chiller at less than preferred levels

Root Cause Findings: Lead / lag controls in the PIC use the demand limit function to load balance. However, the demand limit range is only 40-100%. At 50% load condition, 23XRV chillers are so efficient that they may each only be using 25% of amps. So what happens is one chiller runs at 40% and the other at 10% rather than both at 25%. Object sharing between 19XRV and 23XRV prevent lowering the limit to lower than 40%.

Containment: Use kW as demand limit source

Corrective Action Plan: Break-out shared library. Re-qualify 23XRV S/W
